Tree Inventory and Construction Impacts to Trees at 256 and 292 Gibraltar Drive

Prepared by  
Don Thomas, Medallion Landscape  
Certified Arborist WE-1507  
January 4, 2005

**MEDALLION LANDSCAPE ATTACHMENT G**  
**MANAGEMENT, INC.** Page 13 of 20**Report on Sidewalk Construction Impacts on Canary Island Pines  
At 256 and 292 Gibraltar Drive  
Prepared by  
Don Thomas, Certified Arborist**

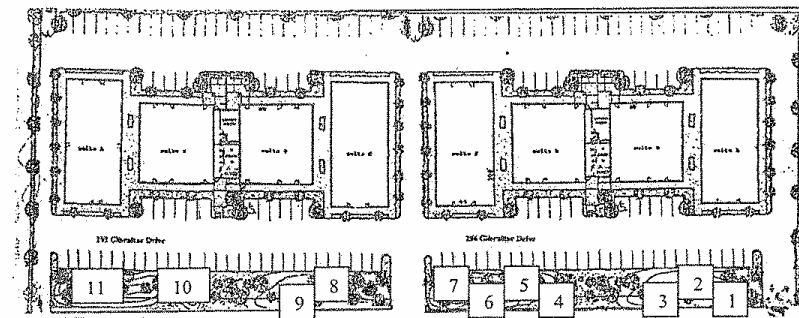
Photograph 1 shows the trees designated as trees 1, 2 and 3 on the site map. It was found that one of the pines, tree 1, has one large root within 5 feet of the curb. This root is shown in Photograph 2. Severing of this root might cause stress to the tree because of reduced water and nutrient uptake.

Tree 3 has a number of large roots within 5 feet of the curb (Photograph 3), and the trunk is only about 6 feet from the curb. This tree would experience significant stress if roots were cut for the sidewalk. Not only would the supply of moisture and nutrients be reduced, but the structural stability of the tree might be compromised because some of the main anchoring roots would be severed. This tree might need to be removed. In addition to the hazard posed by loss of root stability, it also has co-dominant leaders (a

Photograph 1. Canary Island pine trees 1, 2, 3 and 4 in front of 256 Gibraltar Drive.

However, significant stress can be expected for a few of the pine trees if roots are cut, including trees 1, 3 and 5. Tree 3 should be considered for removal. The other trees should be evaluated for stress after construction. Tree 9 may tolerate cutting of the large root near the curb but should be evaluated for resulting stress. Consideration should be given to removal and replacement of tree 11 because of its poor root conformation.
